Developing a Repair Method for Leaking Acid Towers

by Matthias Walschburger, Knight Material Technologies

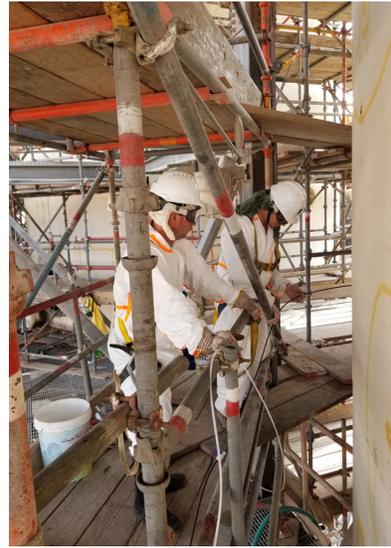
Pecora Mastic Injection

- Another alternative was to inject Pecora Mastic into the void. This needs to be done at a high temperature with solvents present to dilute the Pecora to achieve the required low viscosity to penetrate the narrow space between the steel shell and the brick. The inherent problem of this type of injection is that solvents and flexibilizers - VOCs - evaporate, leaving small evaporation channels inside the resin. This hasn't solved the issue as the acid can flow back to the steel shell, continuing to deteriorate the steel. Therefore, this strategy will work only for a limited period. Furthermore, during wind and seismic activity, if the injected material starts cracking due to the loss of flexibilizers, as is common in Chile, those cracks can contribute to a quicker propagation of the acid attack to the shell.

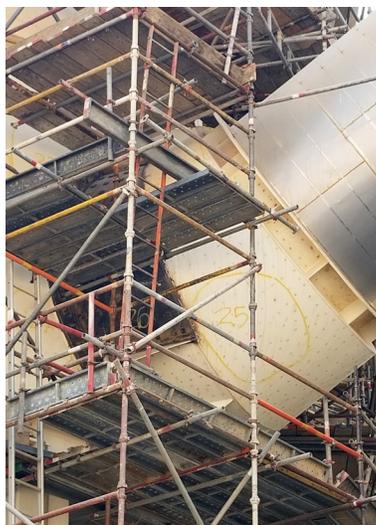
Noracid had already built the scaffold around the tower in looking for other ways to save time. Once on-site, KMT was ready to begin sounding the tower, marking the hollow regions behind the steel shell, and drilling the injection ports. The injection process started from the bottom of the tower, working to the top. In ten days, we had filled the voids previously detected by the sounding, and the plant started up shortly thereafter. With great anticipation, the plant personnel waited to see how the resin would perform and for how long, as the tower had deteriorated so badly.

There will always be some areas the resin will not reach during the initial injection, but newly found hollow spots and/or leaks can be easily repaired during a follow-up visit. Noracid asked KMT four

months later to perform some minor touch-up work at a few injection points, which we were able to complete in two days.

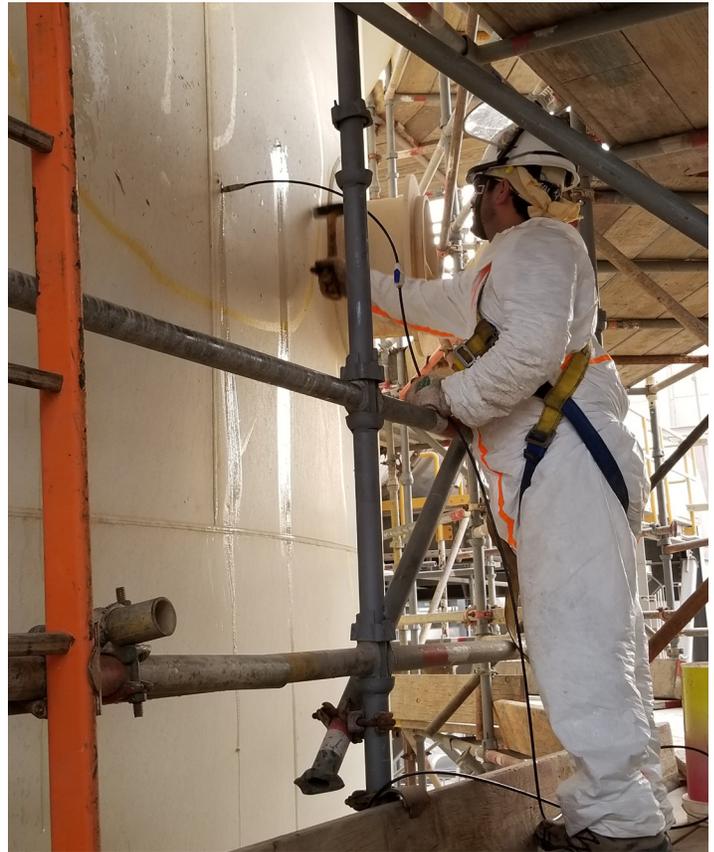
News of this new repair method traveled quickly around the acid-producing companies with acid plants in Chile, including Codelco Ventanas, who had contacted KMT the same year requesting an injection repair. The following year, CodelcoAltonorte were among some of the customers asking for similar injections. Other markets noticed the excellent results and development work KMT had
